Investigative Report

Dated 7/10/2009

Bill Blackwood
Repair Station Manager
Superior Air Parts, Inc.
Coppell, Texas

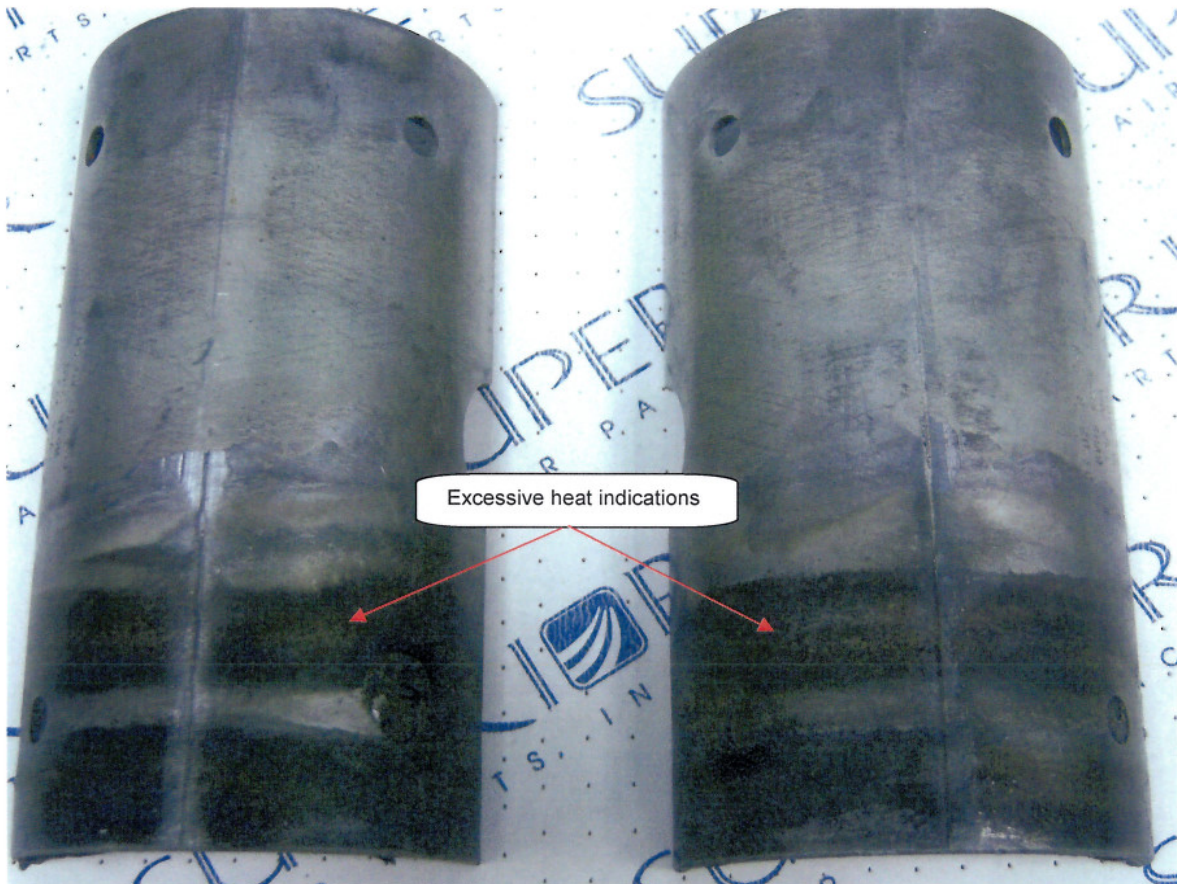
There are excessive heat indications on the outside of the rear third of the bearing.

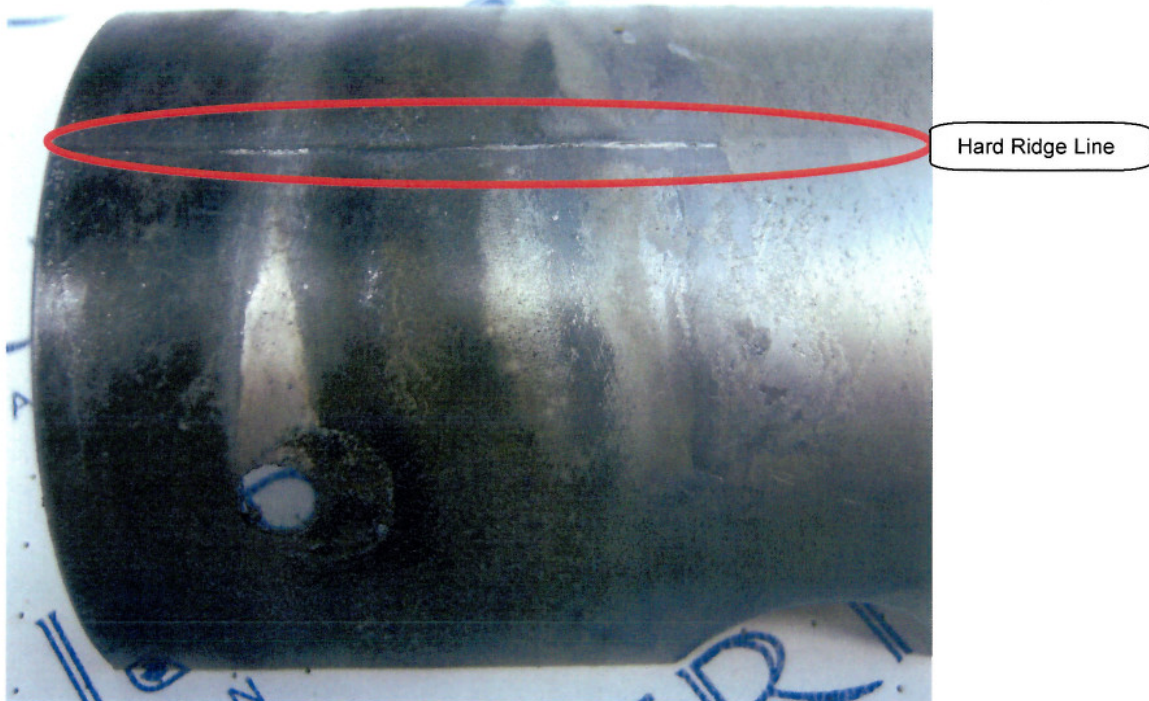
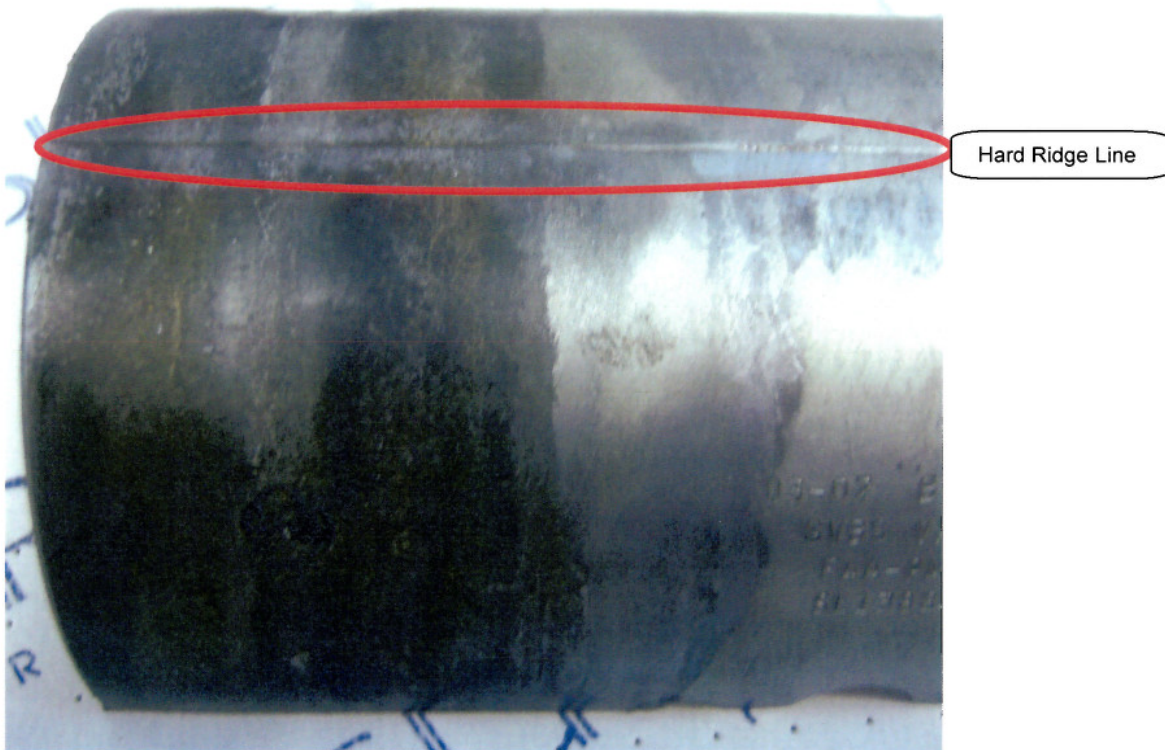
The back of the bearing shell has a hard ridge protruding along its length in line with the crankcase parting surface. This ridge appears to get higher as it approaches the rear half of the bearing.

The ridges that have formed on the bearing shell back and in the crankcase could have formed if the bearing bore hole in the crankcase was too small in the area where the front main bearing was fitted or if the crankcase parting mating surfaces around the thru bolts in that area were not flat or at the proper height. In either situation the bearing to the crankshaft running clearance could be reduced below the minimum running clearance limits when the thru bolts are torqued up to their proper limits.

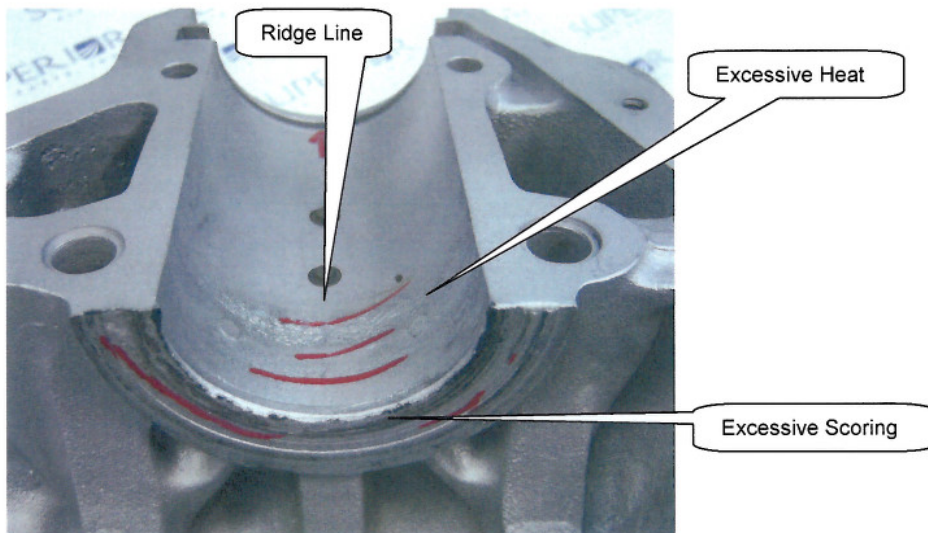
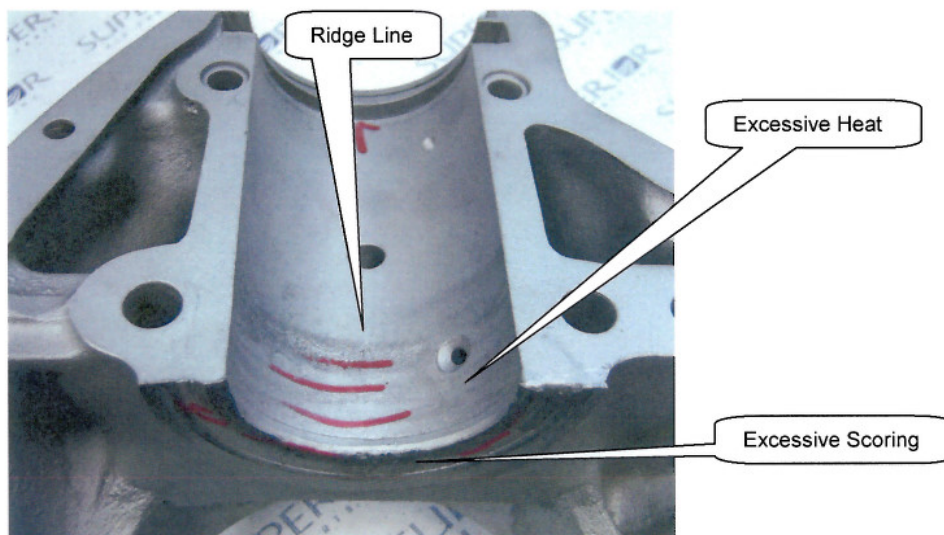
Both Crankcase halves show indications of excessive scoring on the thrust and anti-thrust bearing surfaces. Both crankcase halves show indications of excessive heat in the area where the rear third of the front main bearing is fitted. A ridge has formed in the crankcase at the rear edge of where the front main bearing is fitted. Also a ridge has formed in the crankcase in the area where the front main bearing parting surfaces touch each other. Oil supply passages to the front main bearing were checked and found to be clear.

Discussion: It appears that the oil flow to the rear of the front main bearing was not adequate enough to provide an oil film for complete separation between the crankshaft journal and the bearing.

1. Blockage of the oil supply passages could have caused this but there is no indication that the oil supply passages to this area of the front main bearing were blocked.
2. Improper running clearance between the crankshaft journal and the bearing could have also caused this. Insufficient running clearance in this area would prevent the proper amount of oil film to develop which is needed to support the crankshaft journal and prevent contact between the journal and the crankcase bearing. In addition, there would be insufficient oil flow out of the bearing area to help lubricate the thrust surface area.

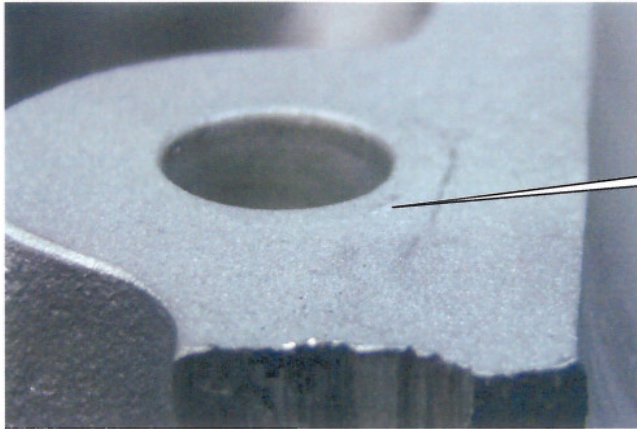
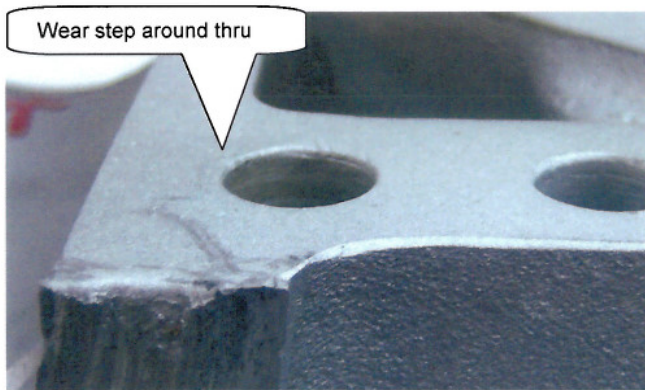
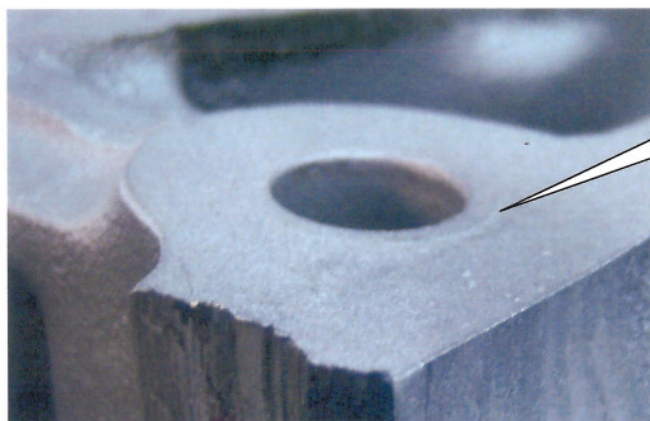
There are indications around the thru-bolt holes in the area of the front main bearing that show a wear step has formed in the crankcase parting surface just outside the diameter of the sealing o-ring that fits around the thru bolt. These wear steps have been bead blasted which tends to blend them into the parting surface making them difficult to identify.
